Determination of wind speed and associated loads over the sports facility collapsed during the severe windstorm of 24 January 2009 in Sant Boi de Llobregat (Barcelona)

J. Mazón¹, D. Crespo¹ and D. Pino^{1,2}

¹Department of Applied Physics, School of Telecommunications and Aeronautics, Universitat Politècnica de Catalunya; C/ Esteve Terrades 5, building C3-116, 08860 Castelldefels

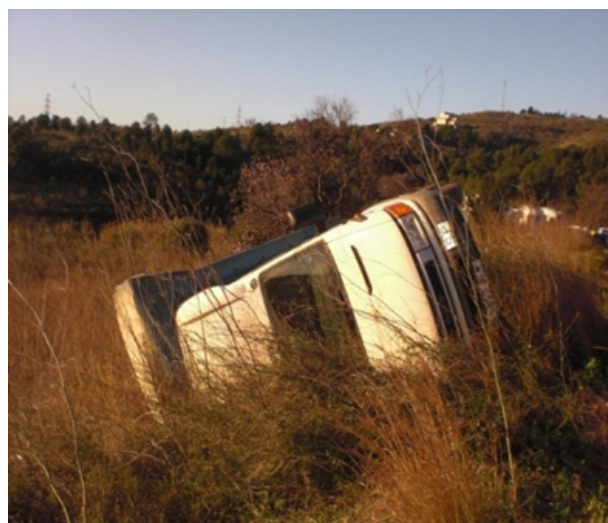
Figure 8. Characteristics and dimensions of the truck dragged by the wind (a, left), which was transversely moved by the wind until it fell into the Fonollar stream (b, right).

At about 250 m from the scene of the accident, a truck (see Figure 8) that was parked on a flat surface and asphalted street was moved transversely due to the wind to a distance of 20 cm, until it fell into an embankment in the stream of Fonollar. The wind struck perpendicular to the vehicle, which was parked on a nearly horizontal surface.
